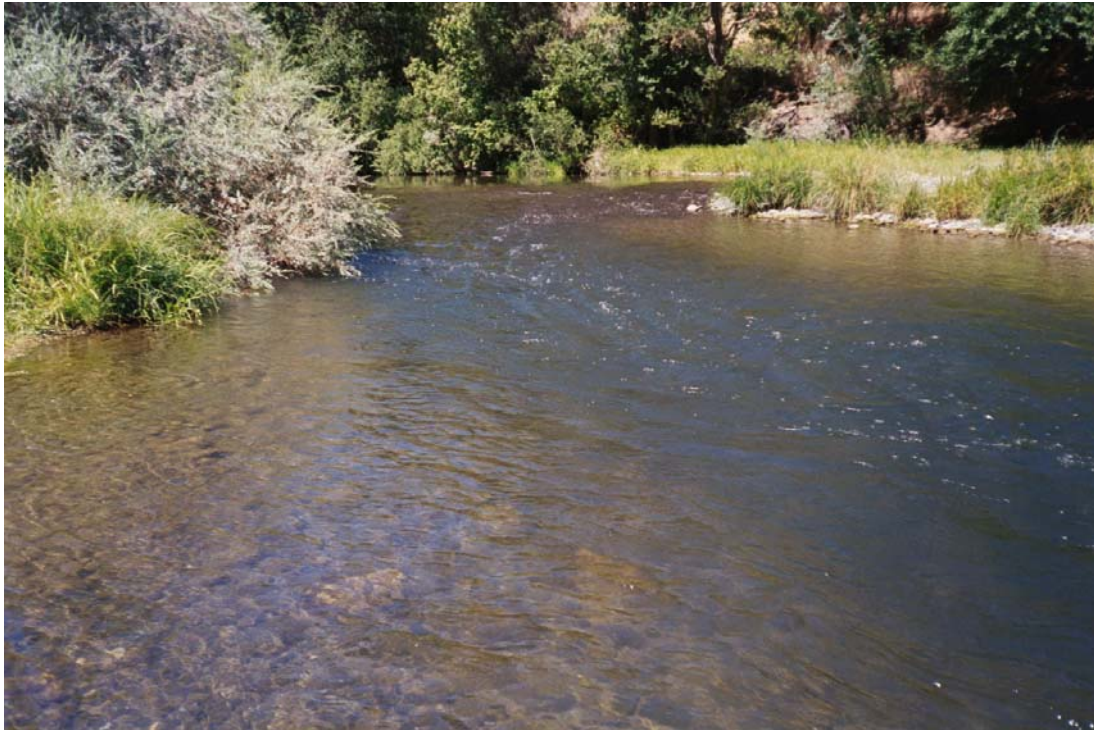
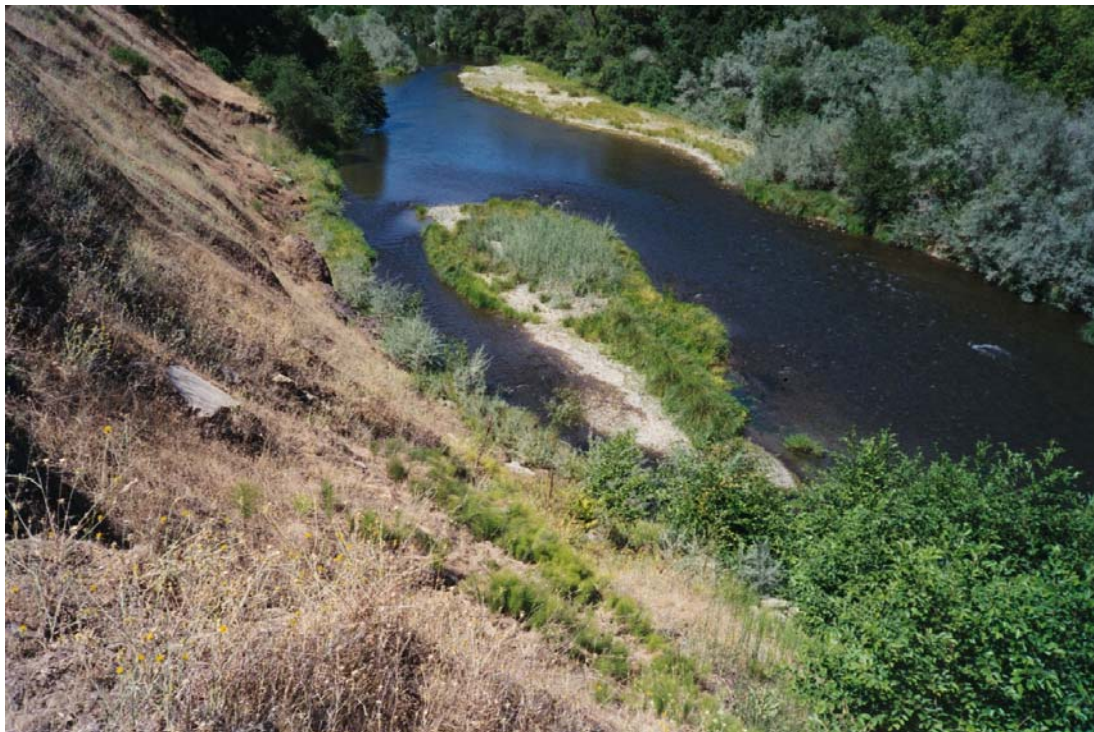
Figure 22: Canyon Reach, Segment C5. This segment contained the largest observation of steelhead ( $n=435$ ). Most steelhead were observed in riffle habitat, which consisted of 13% of the segment. The top photograph shows a steelhead-bearing deep riffle and the bottom photograph shows a narrow riffle on the left side that had 116 steelhead observations.

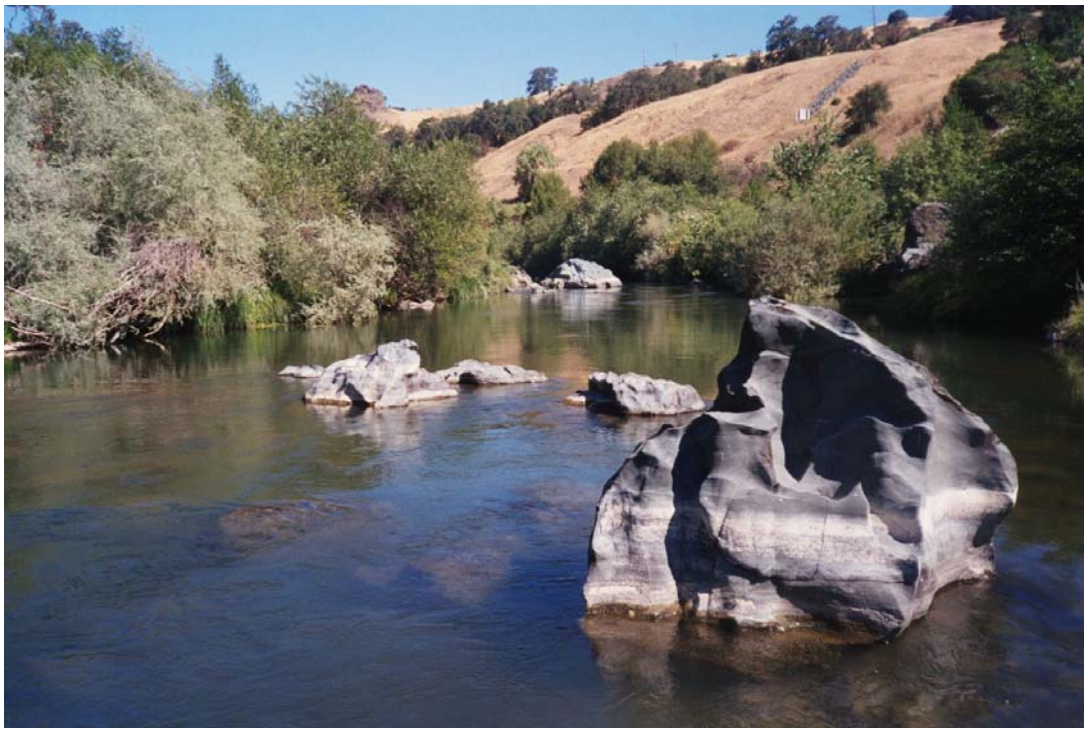
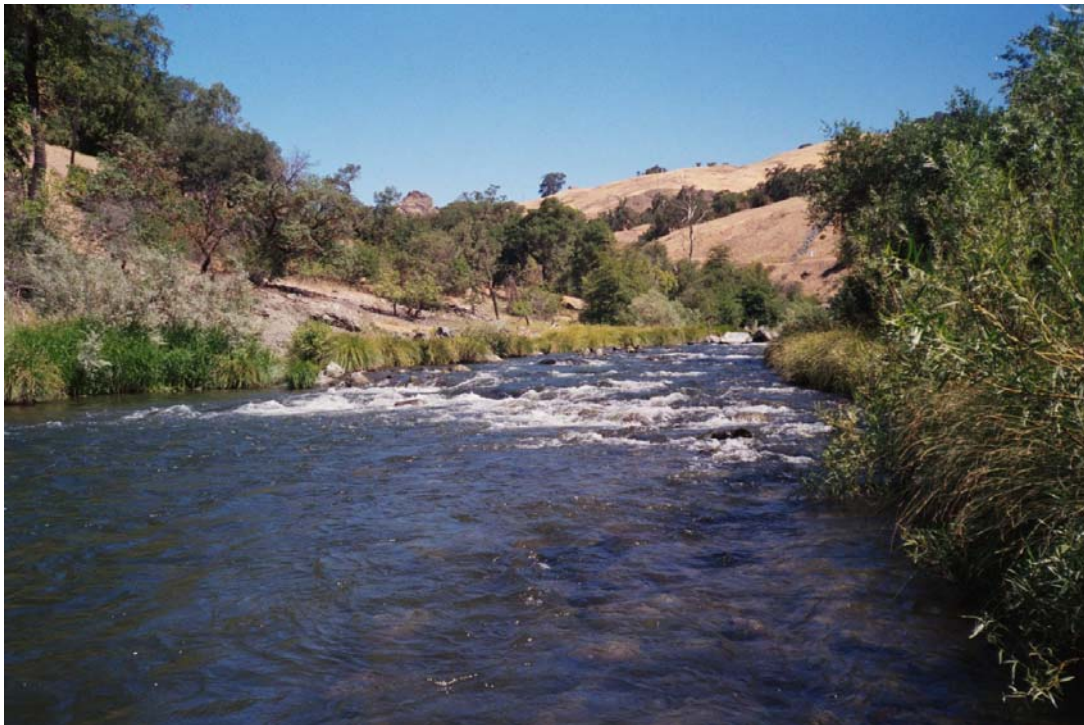
Figure 23: Canyon Reach, Segment C6. This reach was composed of 2% deep pool, 28% riffle, and 70% flatwater habitats. A total of 254 steelhead were observed primarily in riffle habitat. The top photograph shows flatwater habitat with large bedrock boulders and the bottom shows a steelhead-bearing riffle with cobble and boulder substrate.

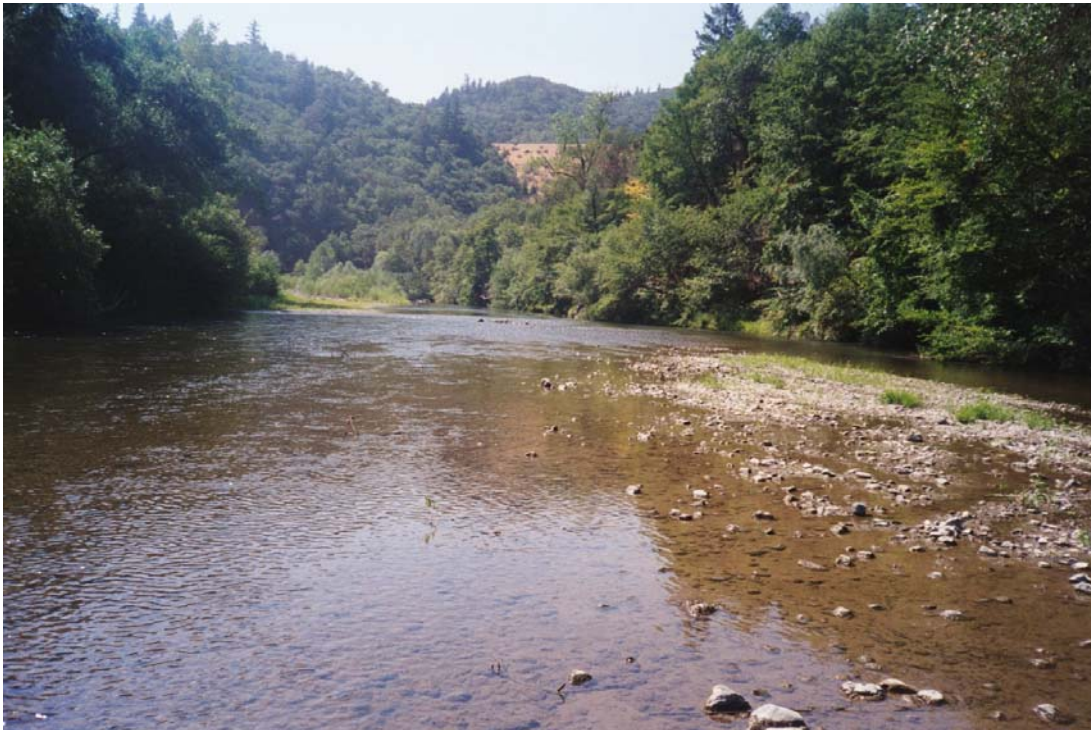
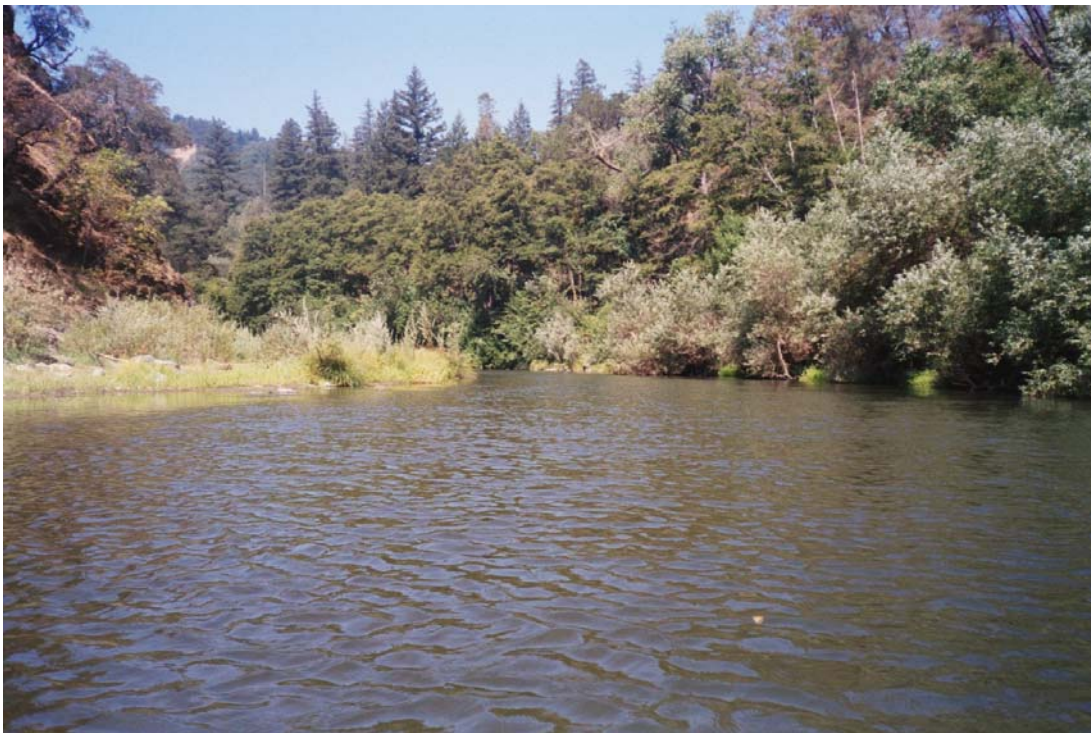
Figure 25: Canyon Reach, Segment C8. A total of 106 steelhead were observed in this segment primarily in riffle habitat. The top photograph shows a broad shallow riffle in the background and an exposed gravel bar in the foreground. The bottom photograph shows flatwater habitat.

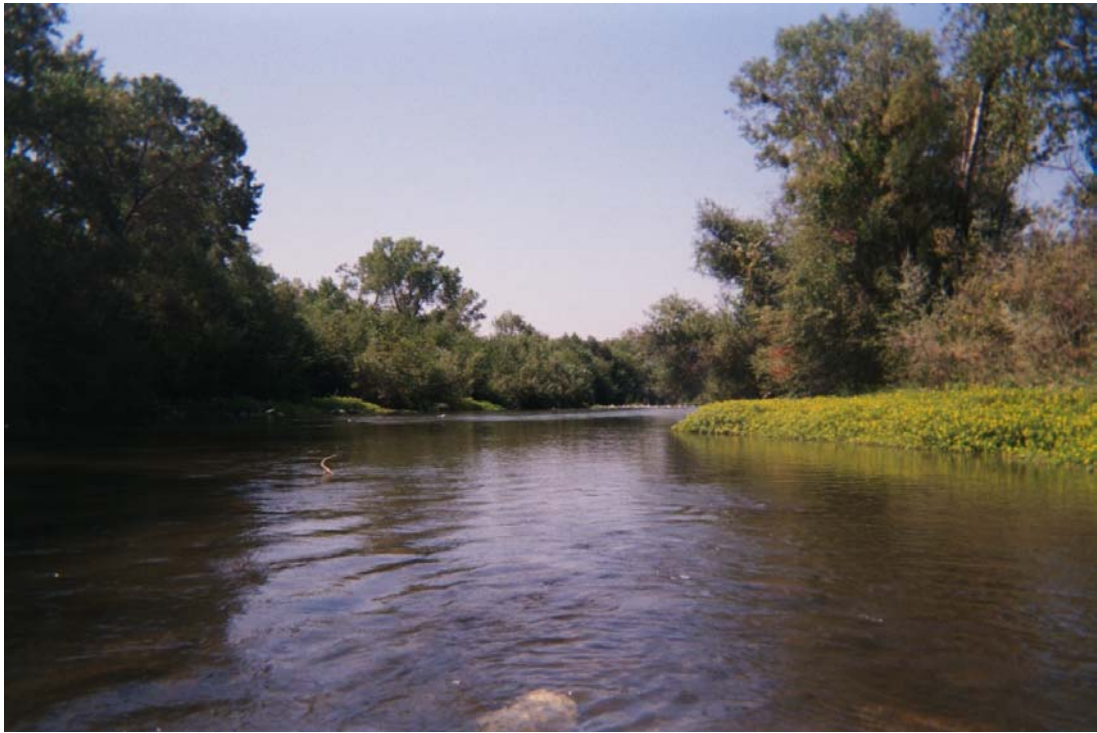
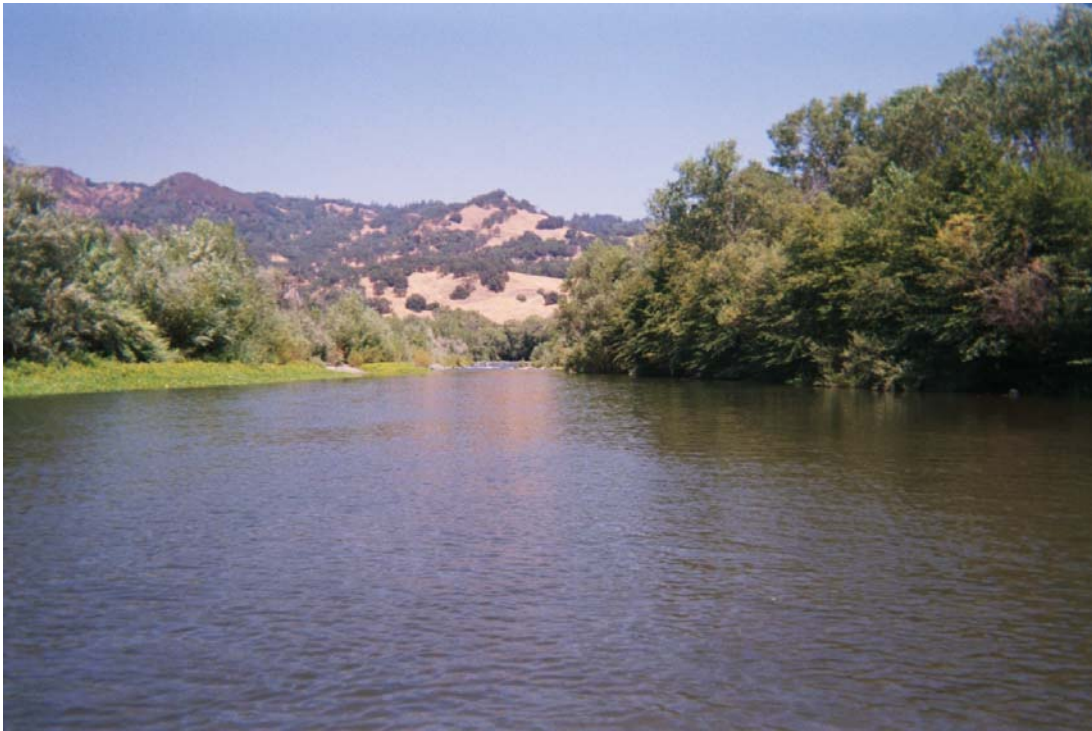
Figure 26: Canyon Reach, Segment C9. This segment is the downstream extent of relatively large steelhead observations. The segment contained 50% riffle and a total of 59 steelhead were observed primarily in this habitat type. Flatwater with riffle habitat in the far background are shown in both photographs.
